## САЛХИТЫН САЛХИН ЦАХИЛГААН СТАНЦЫН БАЙГАЛЬ ОРЧНЫ НӨЛӨӨЛЛИЙН НАРИЙВЧИЛСАН ҮНЭЛГЭЭНИЙ НЭМЭЛТ ТОДОТГОЛЫН ТАЙЛАН

Төсөл хэрэгжүүлэгч: “КЛИН ЭНЕРЖИ” ХХК

## САЛХИТЫН САЛХИН ЦАХИЛГААН СТАНЦЫН БАЙГАЛЬ ОРЧНЫ МЕНЕЖМЕНТИЙН ТӨЛӨВЛӨГӨӨ

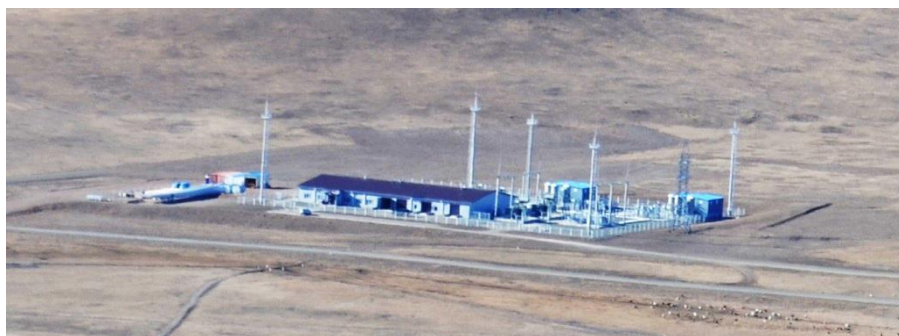
**Figure 2.5 Control building, substation of the wind farm**

WTGs' electric power is transformed in the substation near control building of the wind farm and distributed to the central region's substation via overhead lines.

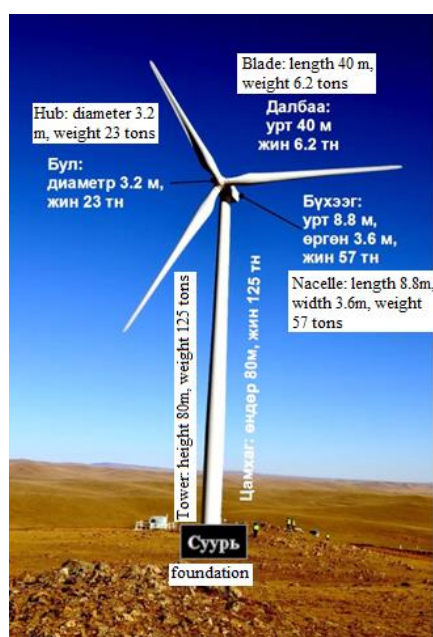
**Figure 2.6 Wind turbine generator**

The WTG has a double-feed induction generator, and this generator is assembled and fixed onto the foundation, in order to reduce vibration and noise transmission.

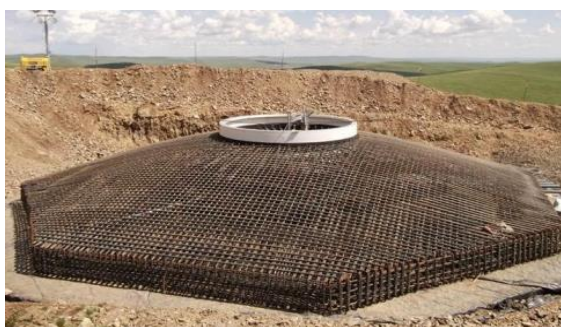
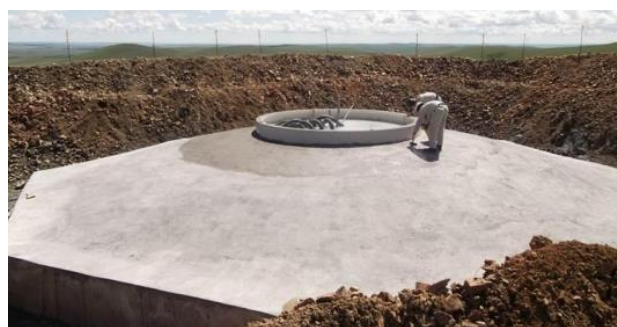
**Figure 2.8 Foundation of wind turbine generator**

Single WTG foundation used 260 m<sup>3</sup> of concrete mix and 50 tons of rebar, was insulated and protected from water and moisture, and then was covered with soil and rammed down.

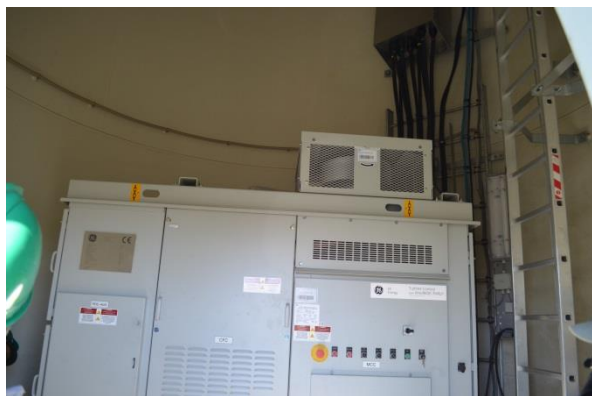
The inverters that changes alternating current (AC) to direct current (DC) and DC to AC are installed inside the WTG tower, and also 35/0.69 kV amplifying transformer are installed outside the tower.

Source: Assessment team of supplementary  
**Figure 2.9 Inverter inside the tower**

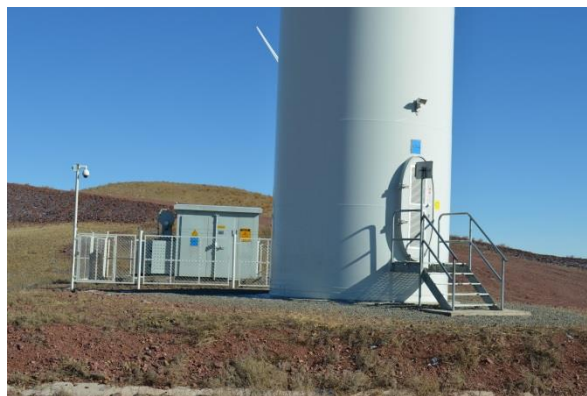
clarification of DEIA, 2016  
**Figure 2.10 35/0.69 kV amplifying transformer outside the tower**

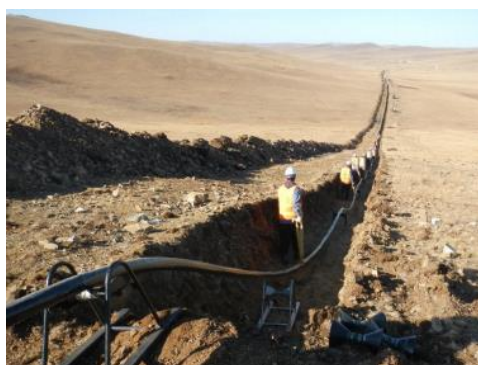
Source: Assessment team of  
**Figure 2.11 Cable installing process**

WTGs, bundled into four separate groups, are connected to the substation by 35 kV underground cables. Cable total length is 27 km. And, data transmission fiber optic cables are installed in the cable canal of the wind farm.

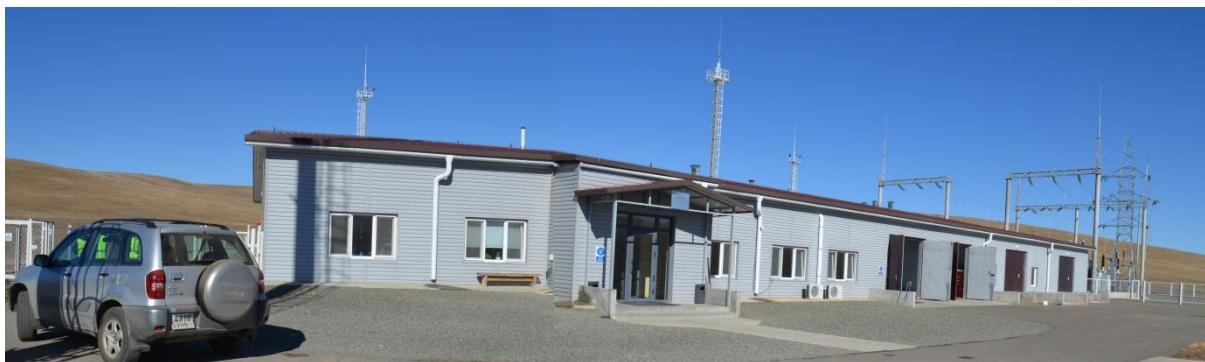
**Figure 2.13** Wind farm's control building

**Control building.** Wind farm’s control station is built with light and high heat retaining capability “Thermoblock”. The station has a high efficiency electric heating system.

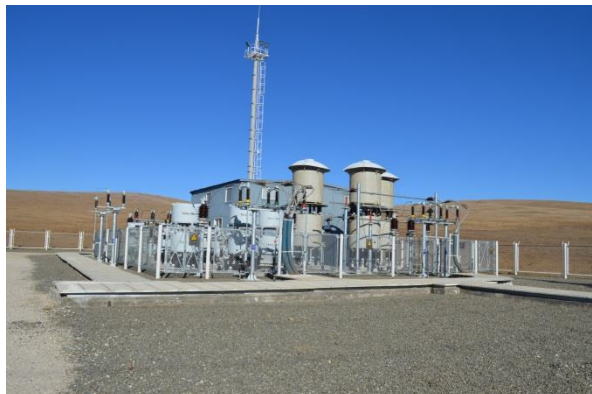
Source: Assessment team of supplementary clarification of DEIA, 2016  
**Figure 2.15 35kV voltage stabilizer**

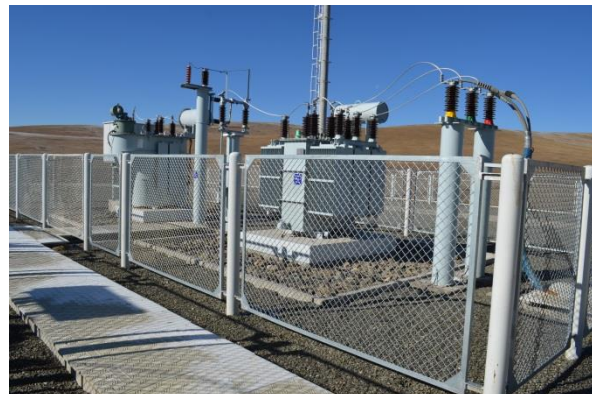
**Figure 2.16 35kV electric arc dissipating coil**

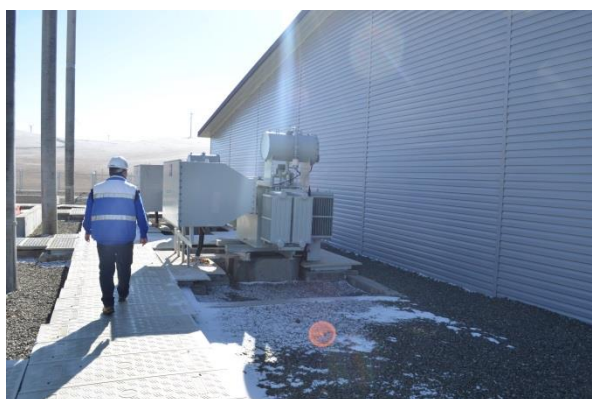
Source: Assessment team of supplementary clarification of DEIA, 2016  
**Figure 2.17 35/0.4kV domestic usage transformer**

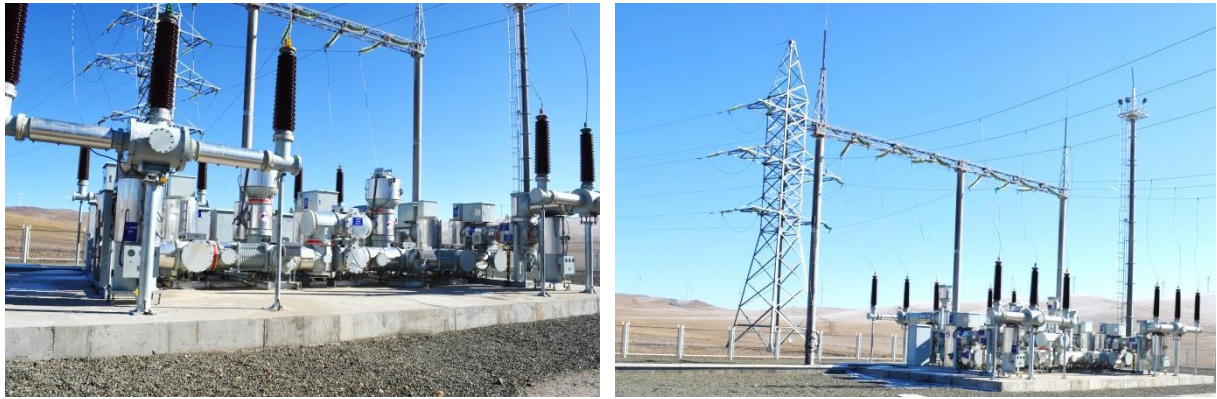
**Gas insulated switchgear.** Gas insulated switchgear(GIS) is the newly introduced technology in the Mongolian energy sector. The switchgear takes less space, highly reliable, with low maintenance cost and have a long lifetime. The facility is environmentally friendly since it doesn't use insulating oil. Sulfur hexafluoride (SF6) gas has minimal environmental impact as it is world piloting new eco-efficient gas mixture.

**Figure 2.20 110kV gas insulated switchgear from the right and front side**

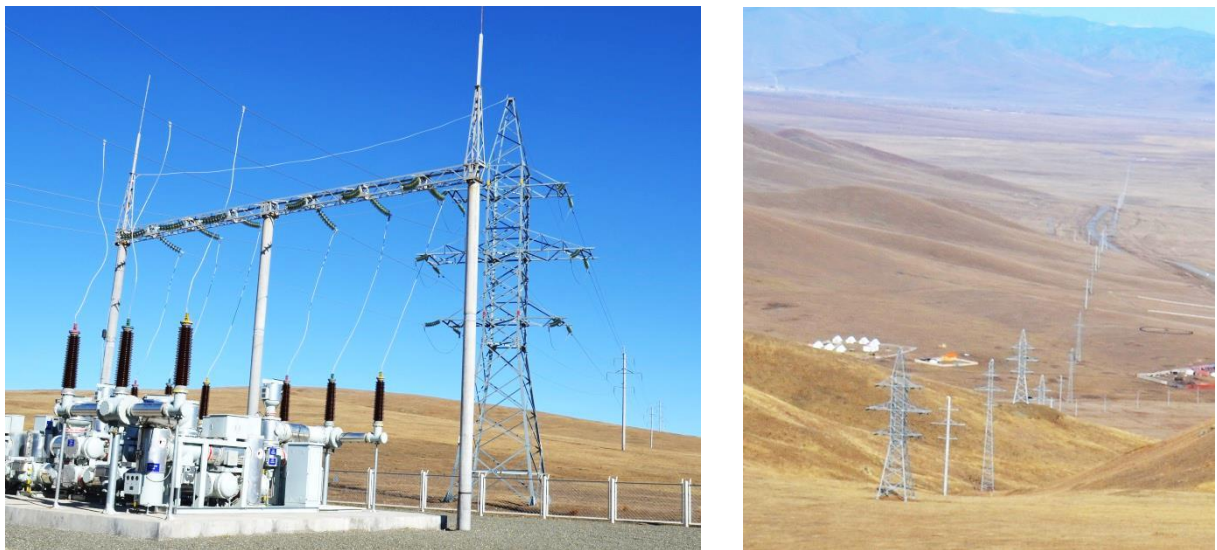
**Figure 2.21 110kV double circuit overhead transmission line has been built to Nalaikh’s substation from the gas insulated switchgear.**

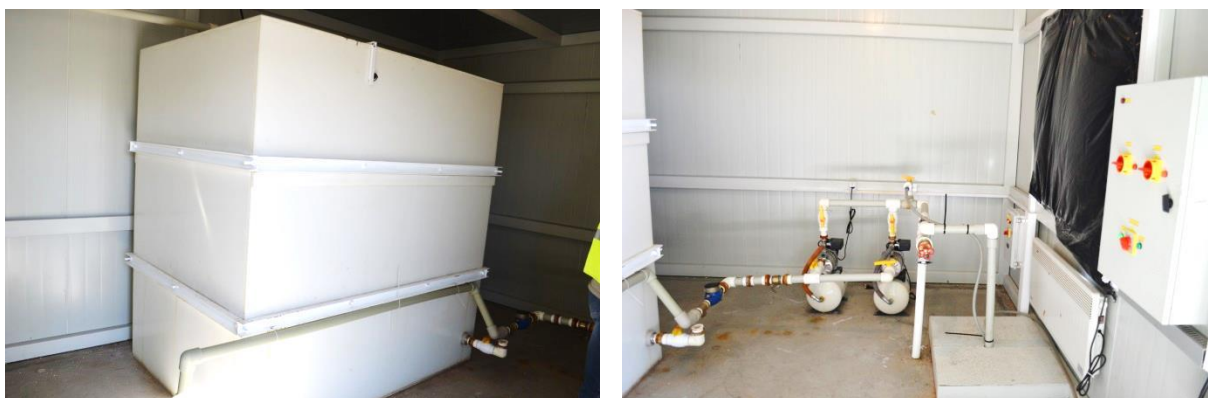
**Figure 2.27 Well equipments**

**Water usage.** Wind farm technology will not use water for repair and services. Drinking water is transported from Nalaikh. Water from the well next to substation will be used for housefold usage. Well is equipped with water meter.

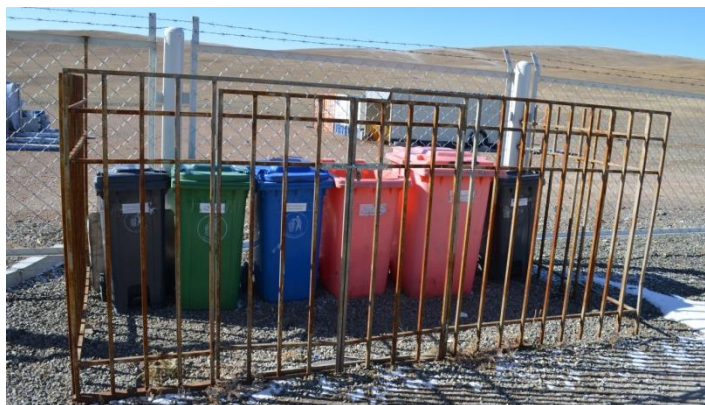
**Figure 2.28 Solid waste storing containers**

**Solid waste.** Solid and organic waste emitted from wind farm’s industrial maintenance and control building is sorted out then deposited in purpose built plastic container. According to contract made with Nalaikh’s landscaping and services company, waste is disposed twice a month.

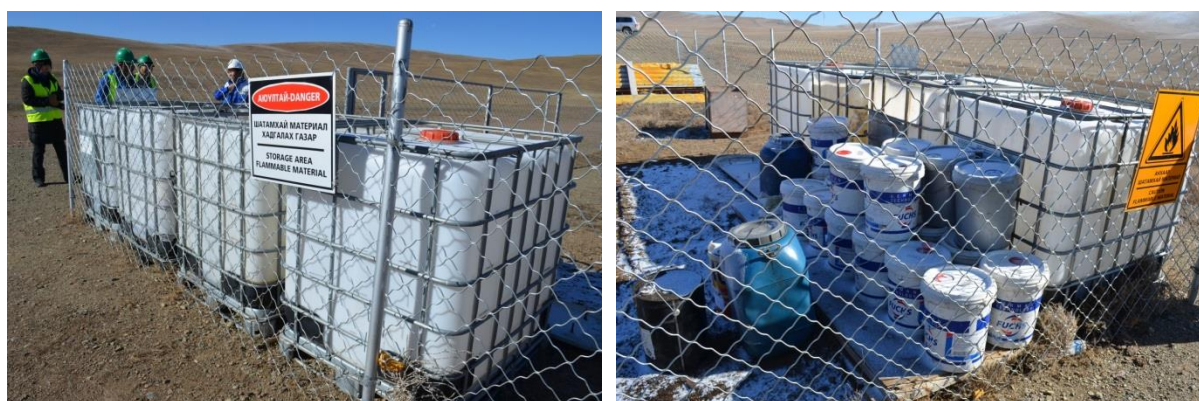
**Figure 2.29 Waste storing containers for lubricating oil materials**

Oil from equipment and rotating mechanism is replaced on scheduled time; and waste oil is temporarily stored in special containers and sold to the market. For example in 2016, 1 ton waste oil from WTG was transported to Altan Orshikh Group LLC’s Akhui Mandal oil refinery, located in Bagakhangai district, according to contract.

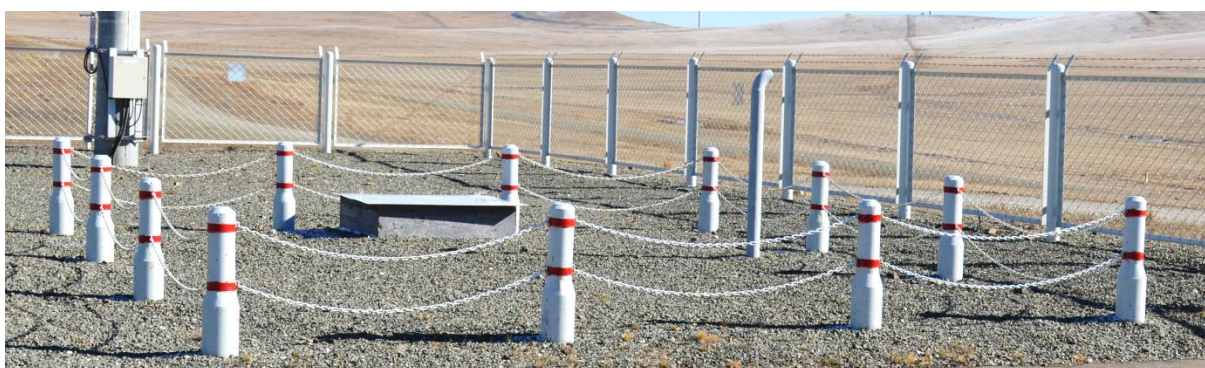
It has become possible to pour accidentally leaked lubricating oil into underground 40 m<sup>3</sup> drainage BAK, located under transformer base, to prevent substation transformer lubricating oil leaking into the soil.

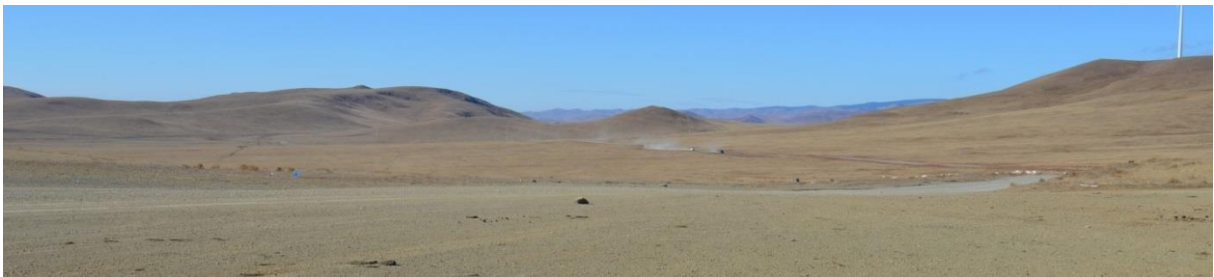
**Figure 3.7 Vehicles passing 7th WGT by unpaved road**

The above indicators measured next to 10<sup>th</sup> WGT, which is unpaved road crossing through the project site, had a higher concentration than standard MNS4585:2007. The small and large particulate measurements along the project site crossing unpaved road are exceeding standards due to constant use by the vehicles of “Monkhiin bayangal” LLC’s cement factory, and this indicates there is a medium degree of pollution. In addition, emission and dispersion of those pollutant contained in the exhaust smoke of vehicles will remain along the road. Along this road amount of pollutant concentration and dispersion can be minor within the limited area, as the traffic concentration is low.

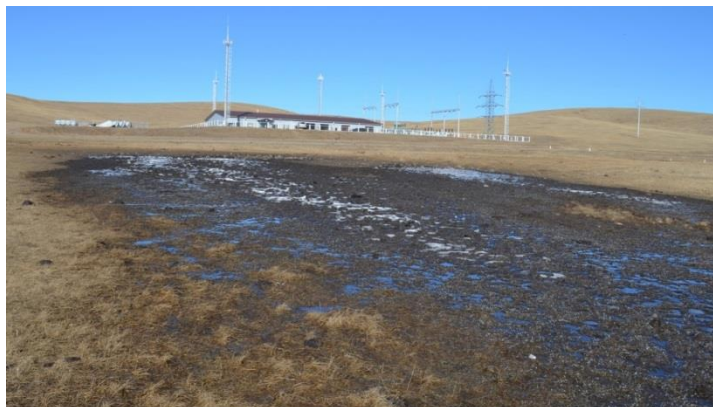
**Figure 3.9 Spring near control building**

According to people’s oral report, it has been gushing slowly for the last 2 years. This spring did not any create definite watercourses; it was not possible to take a water sample for testing, because livestock has stepped on and defecated on the oozing part of the spring. Spring yield cannot be measured, no watercourse was not created. Water spreads over a distance of 30 meters. Spate forms in winter. Sprint does not have a protection.

However, the spring near the the southwest of substation needs to be fenced from animal; it should be freed of pollution.

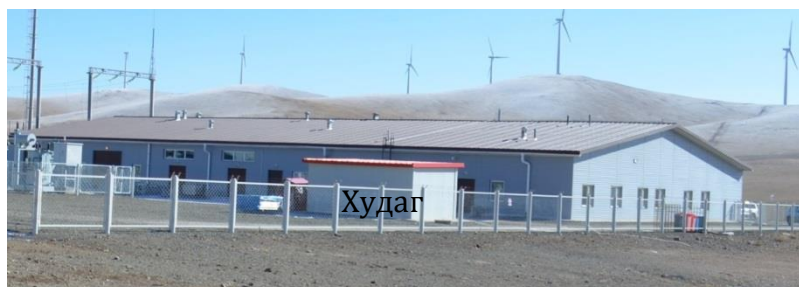
**Figure 3.10 Well located southwest off control building**

During project building construction, 2 wells were drilled to use groundwater. Well yield is 1.5-1.0 l/s. Presently, production well is prepared to be transferred community. On the other hand, control center’s well is being pumped for only everyday usage.

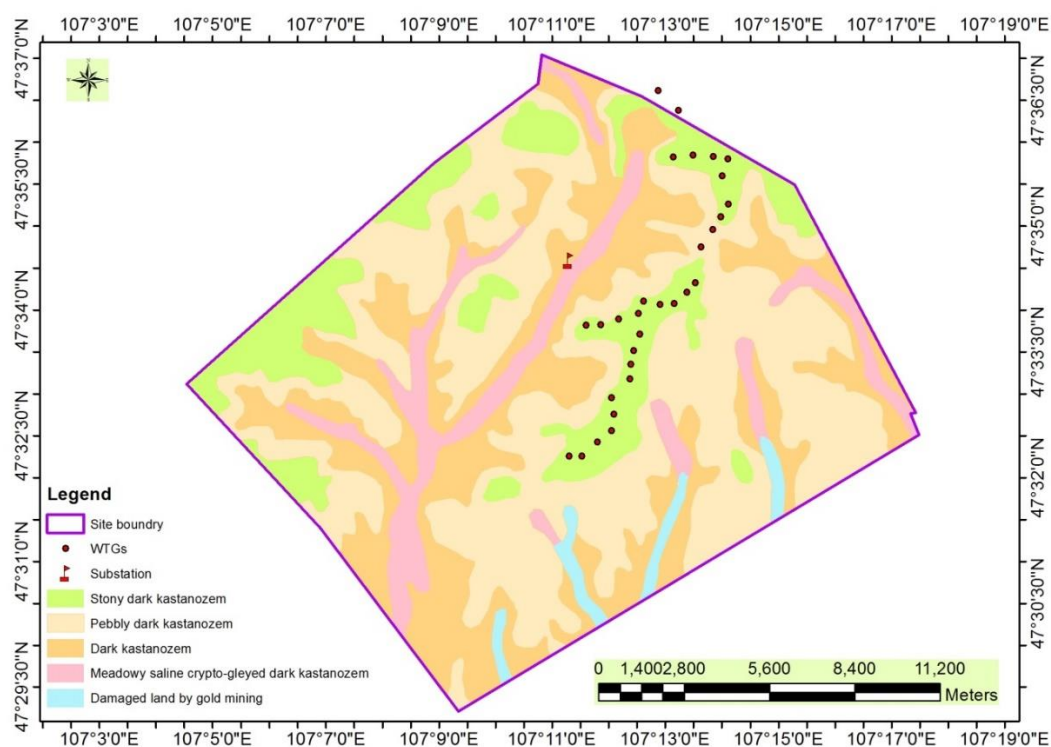
Therefore, we used 1:100000 scale topographic map and Google-earth map to develop an outline soil map in conjunction with soil distribution concave convex elevation, soil layers condition, surface slope, bedrock depth, soil water, vegetation separated by soil feature types as rocky, pebbly, normal, meadowy, and some major soil humus layers were divided by thin, medium, and thick. This map is useful for future soil study and monitoring project.

Moreover, damaged soil from gold mining, located southern part of licensed area, is marked on this map.

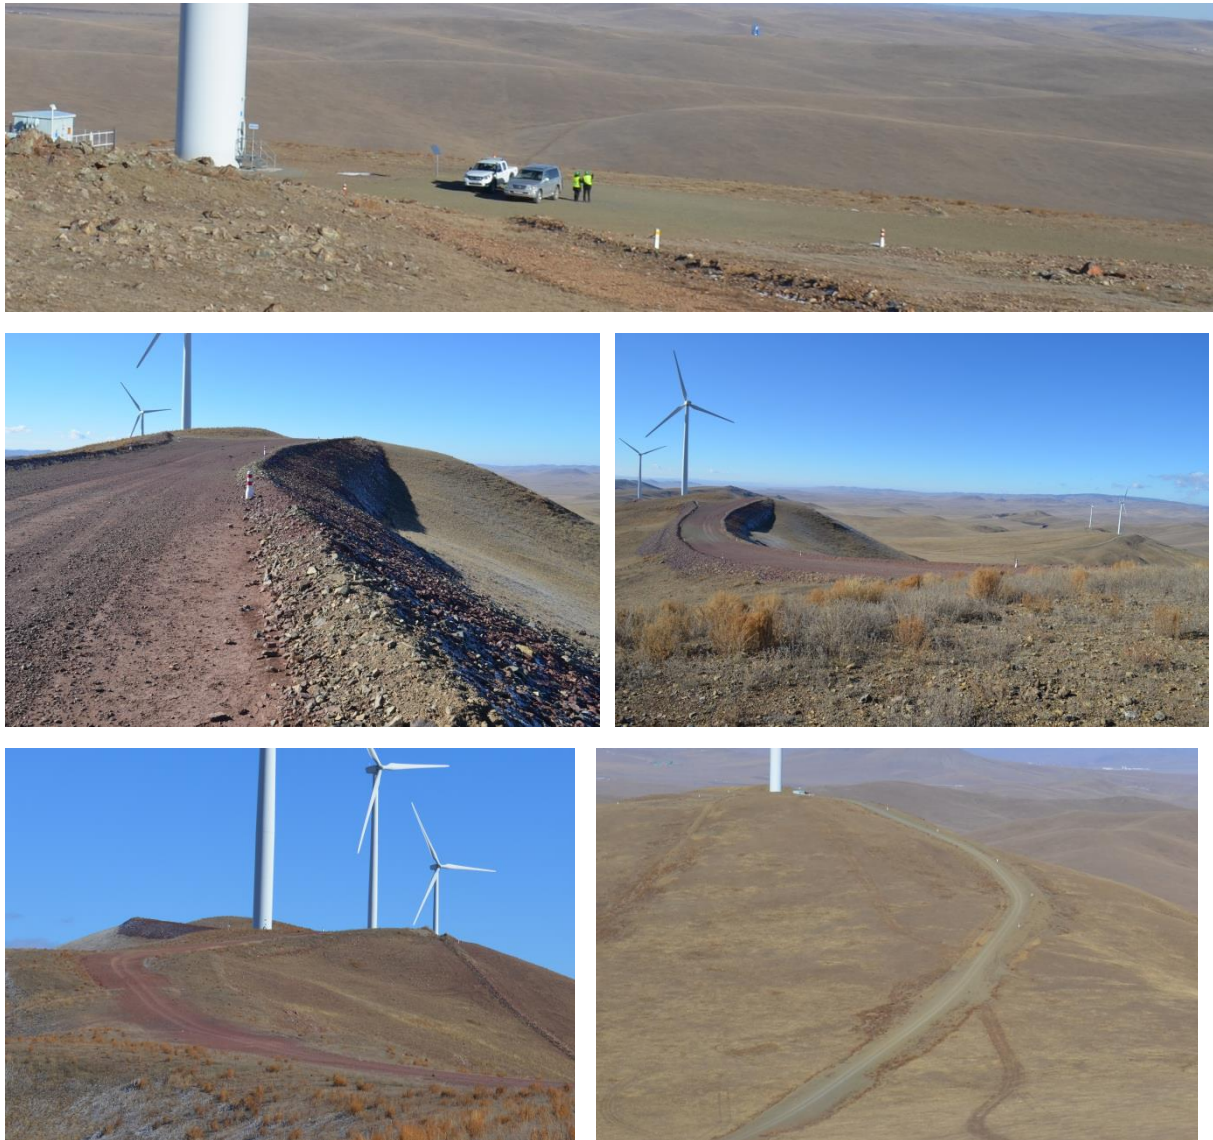
**Figure 3.16 WTG’s car parking space, unpaved road.**

Mountain tops flattened to build WTGs, and road has been constructed between them.

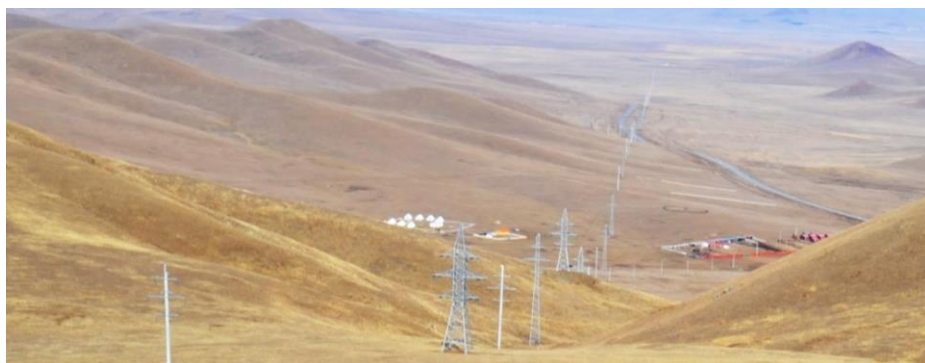
**Figure 3.17 Location of 110 kV overhead power transmission line**

110 kV overhead power transmission line has been built from north east of the substation to Nalaikh’s substation through hilly areas and flat steppe.

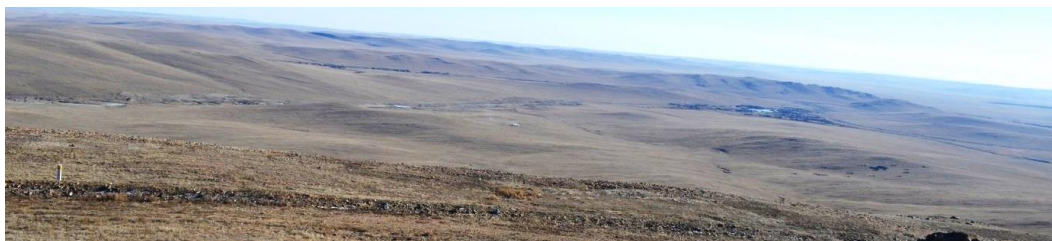
**Figure 3.19 Damaged land by gold mining**

Soil is affected by gold mining operation in the 4 dry riverbed or south western part of the “Clean energy” LLC’s owned land. These damaged lands are situated at a distance of 1.7-2.9 km from the western WTG’s. Gold mining operations are held during warm season.

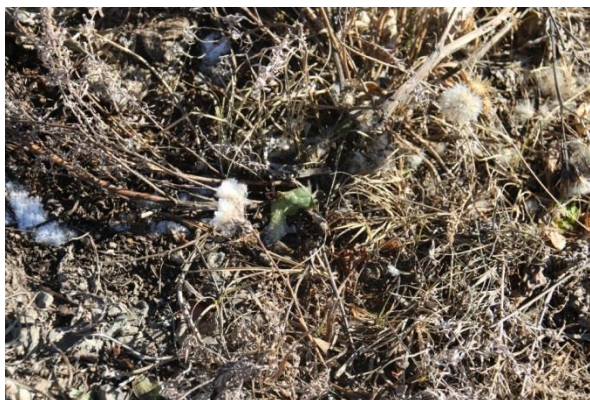
**Figure 3.20 Camp location restoration**

The habitat is recovering relatively fast back to its initial condition, as this region is dominated by perennial grasses with robust root system, which are resilient and able to withstand degradation.

Implementation of biological reclamation on damaged land due to project construction work is successful, as of now reclaimed areas are safe, formed sustainable landscape and covered with appropriate amount of vegetation. There can be seen /Figure 3.20/ an increasing natural plant participation as some species of plants /*Cleistogenes squarrosa*, *Stipa Krylovii*, *Poa botroides*, *Koeleria macrantha* etc./ are growing intrusively into some parts of the reclaimed areas.

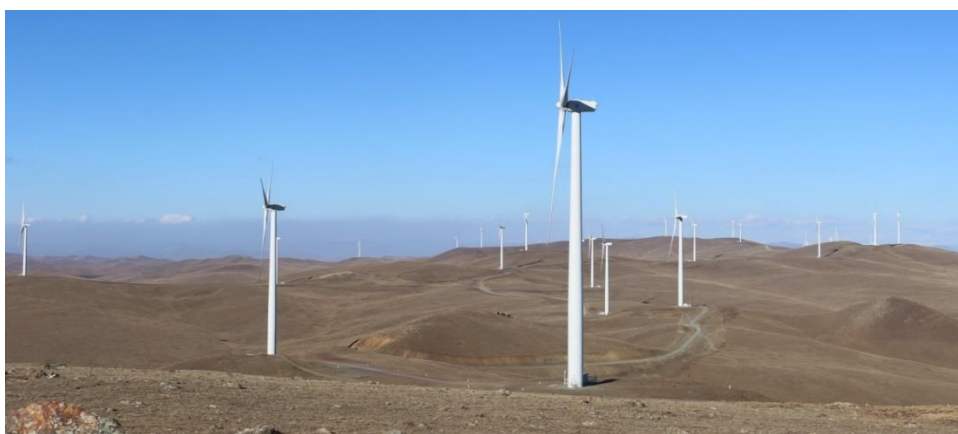
**Figure 3.22 Road between WTGs.**

Due to definitive roads and tight monitoring on wind farm’s project site prevented negative impacts on carrying capacity, therefore currently no specific negative impacts on environment are observed /Figure 3.22/.

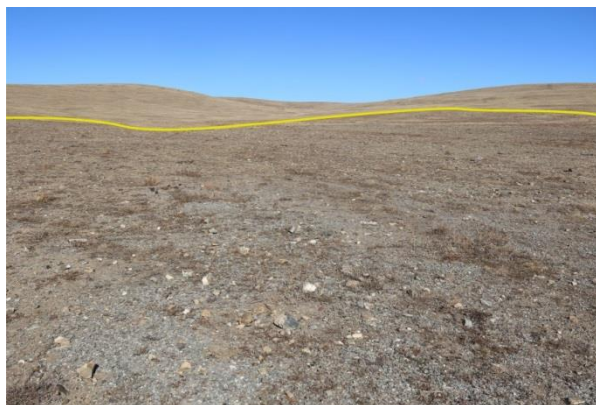
During plant construction, due to biological restoration on the field where workers camp, vehicle parking, concrete batch plant located, the landscape formation has become safe and covered with certain amount of vegetation and some neighboring dominant species of natural vegetation has grown on these fields.

**Figure 4.3 Reclaimed field boundary /some dominant species grown in natural vegetation/**

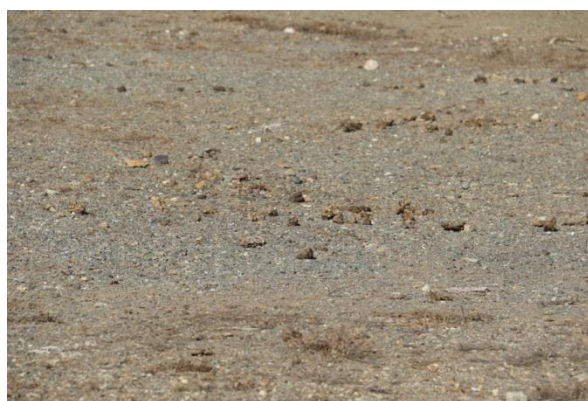
Considerable impact of livestock is having a dampening effect on the process of vegetation of this field gradually turning to natural pasture.

**Figure 4.4 Livestocks graze a lot over reclaimed field**

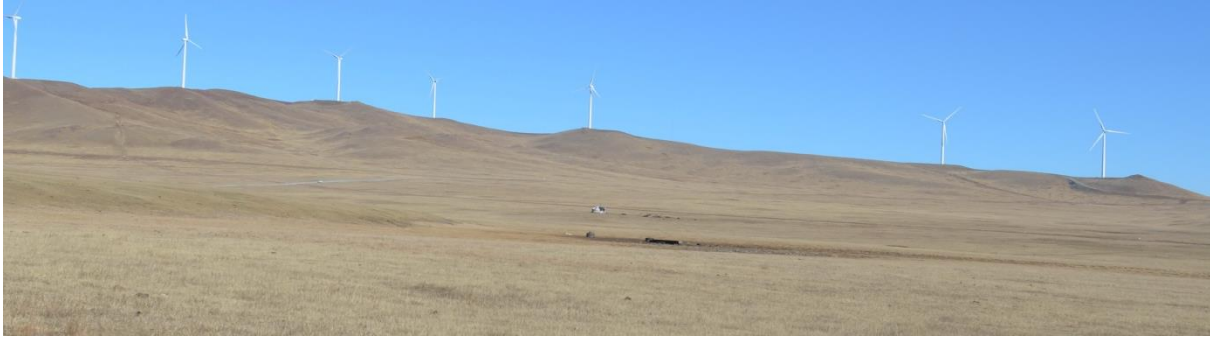
**Figure 4.8 Hand-dug well at the wind farm possessed land**

There is no facility that hinders the path the grazing livestock take to reach their water supply. Grazing livestock are watered using hand-dug well and springs.
